47<sup>TH</sup> TURBOMACHINERY & 34<sup>TH</sup> PUMP SYMPOSIA  
HOUSTON, TEXAS | SEPTEMBER 17-20, 2018  
GEORGE R. BROWN CONVENTION CENTER

# Motion Amplification: A New Way to Visualize Vibrations

Jeff Hay PhD, CEO RDI Technologies

# Case Study - Stator Motor Pump

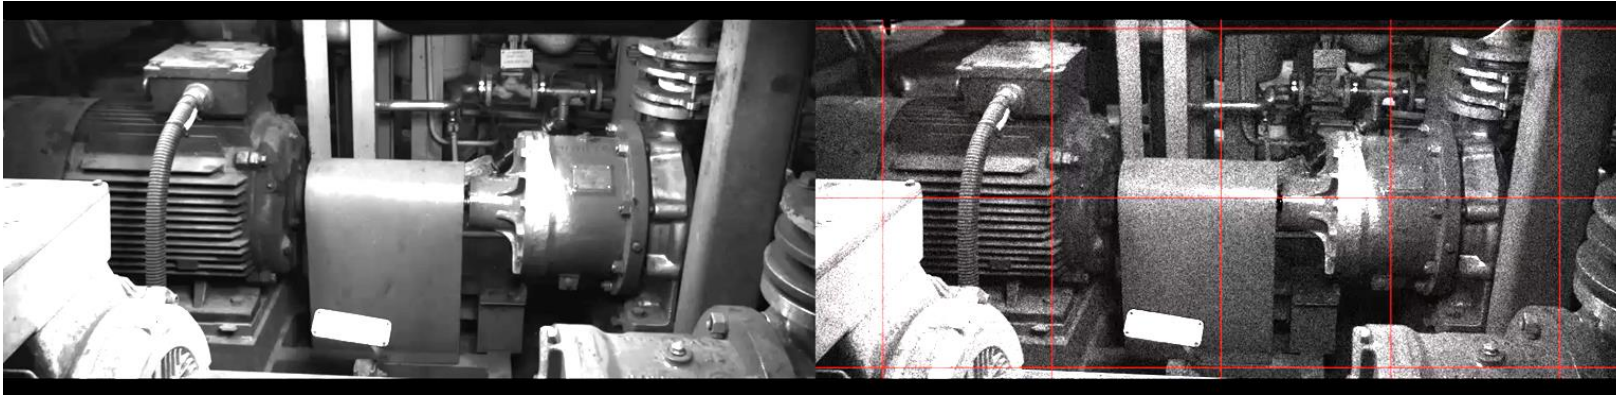
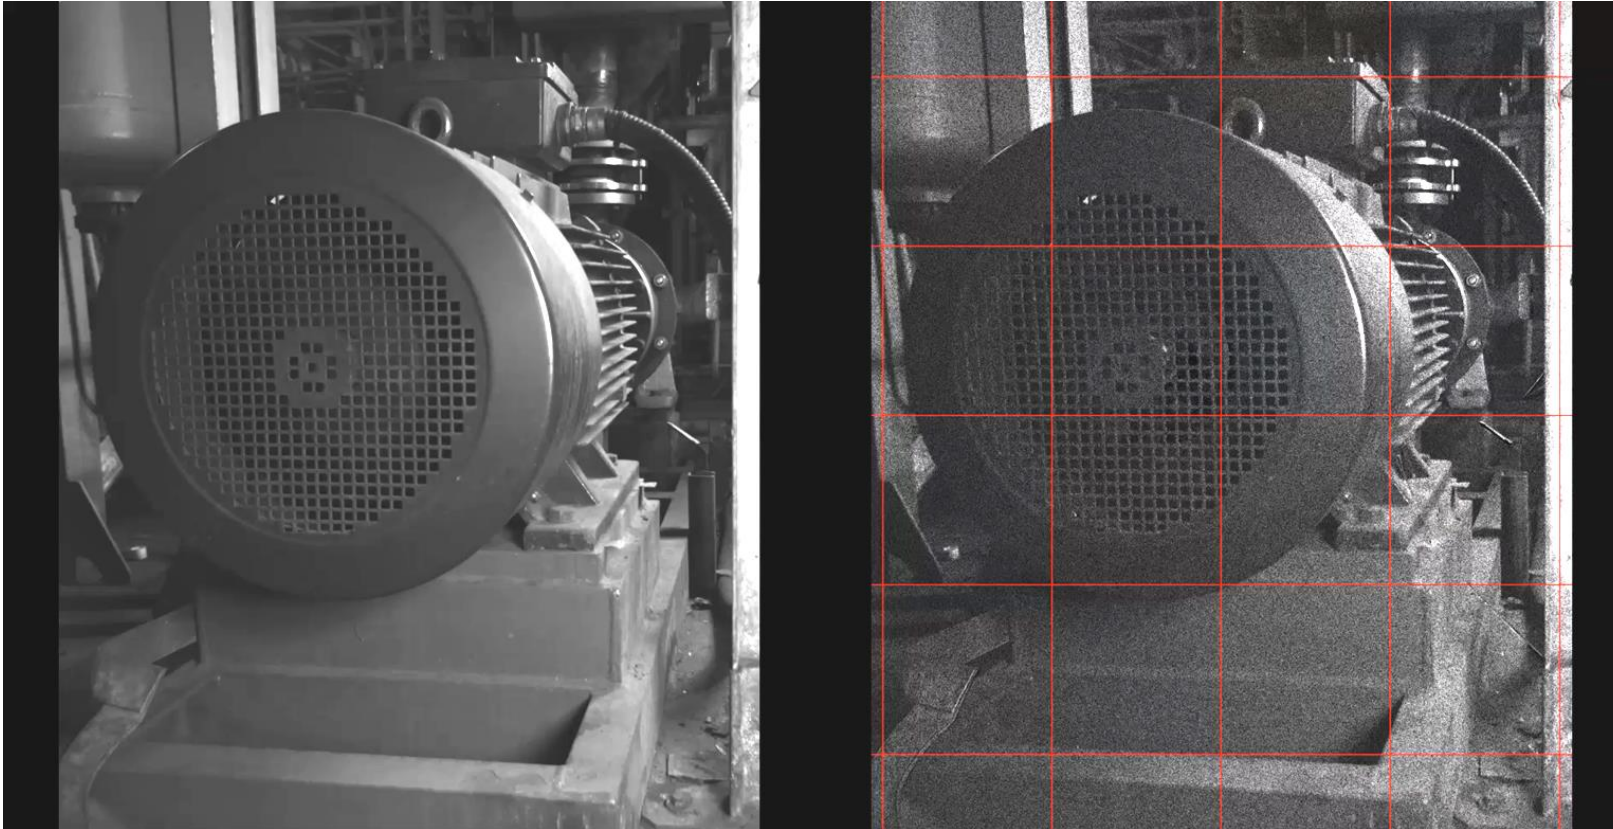
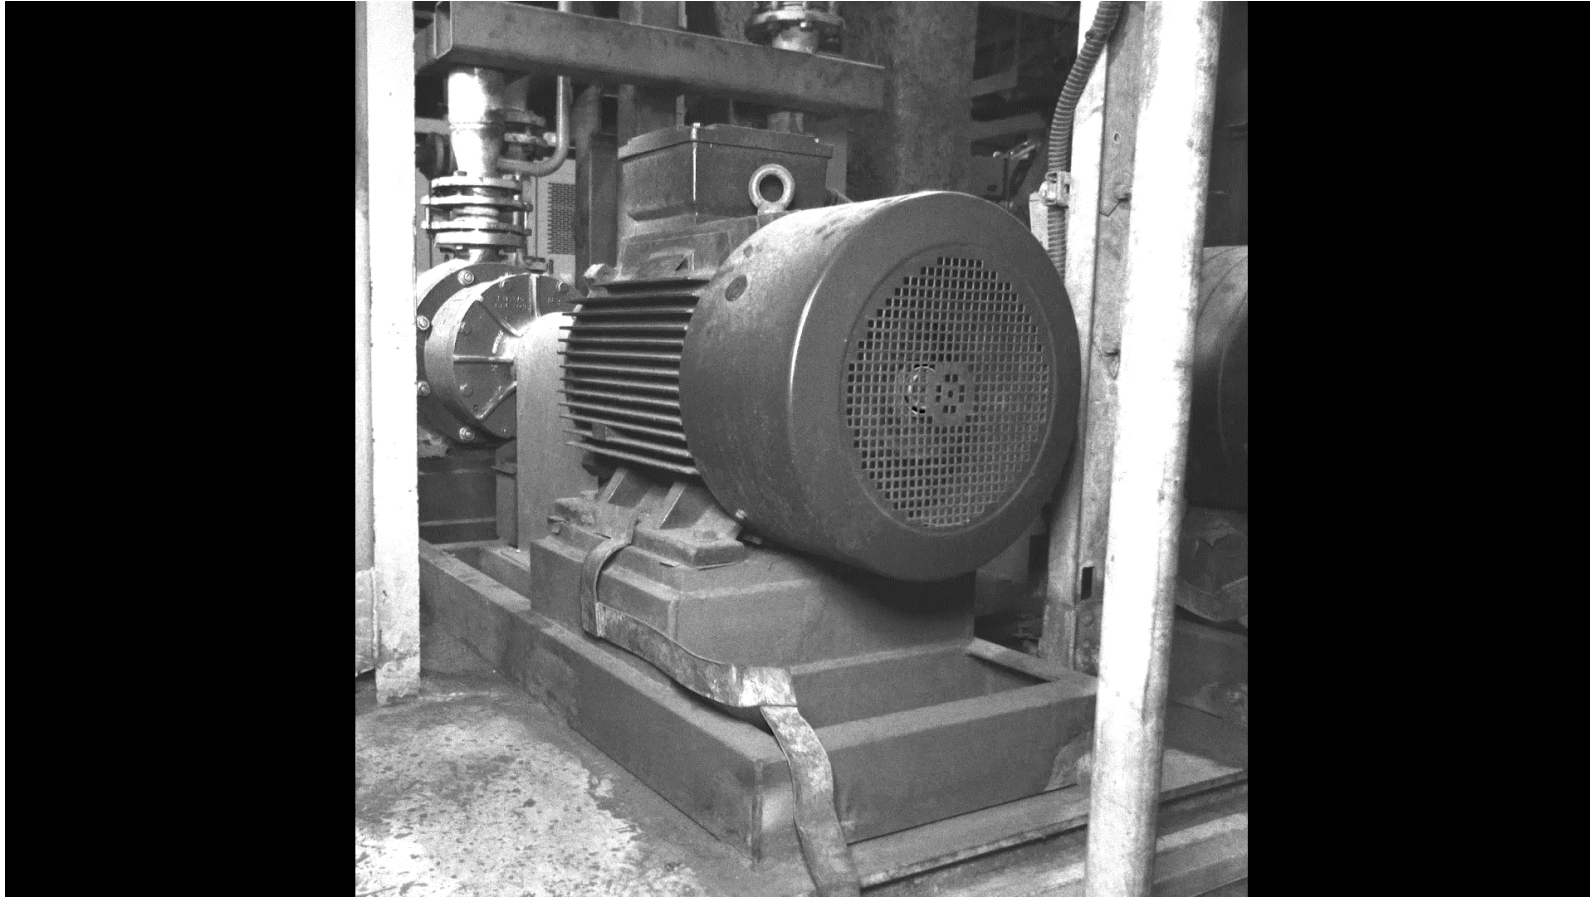
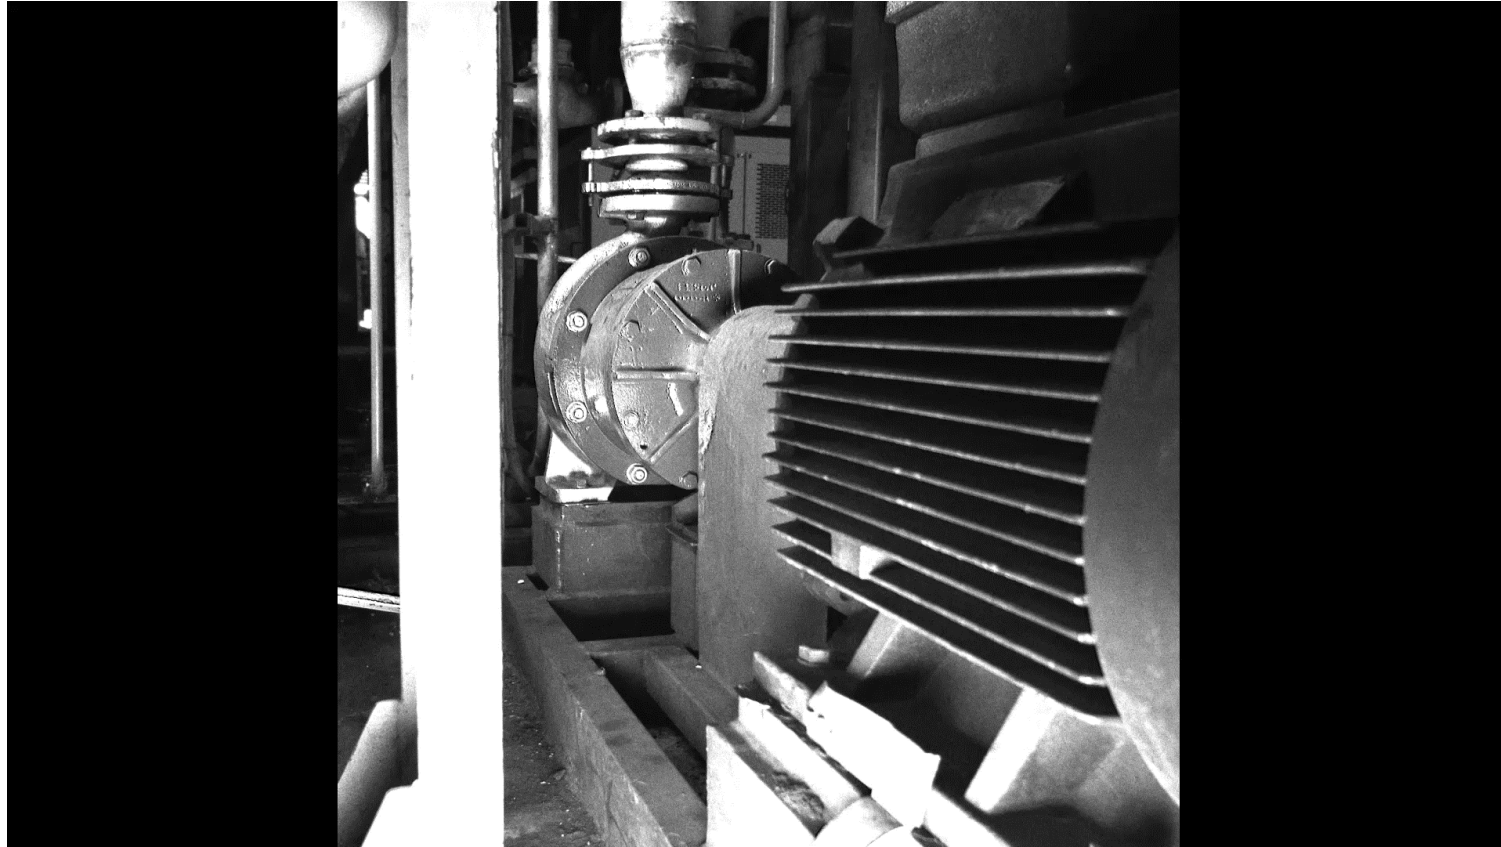
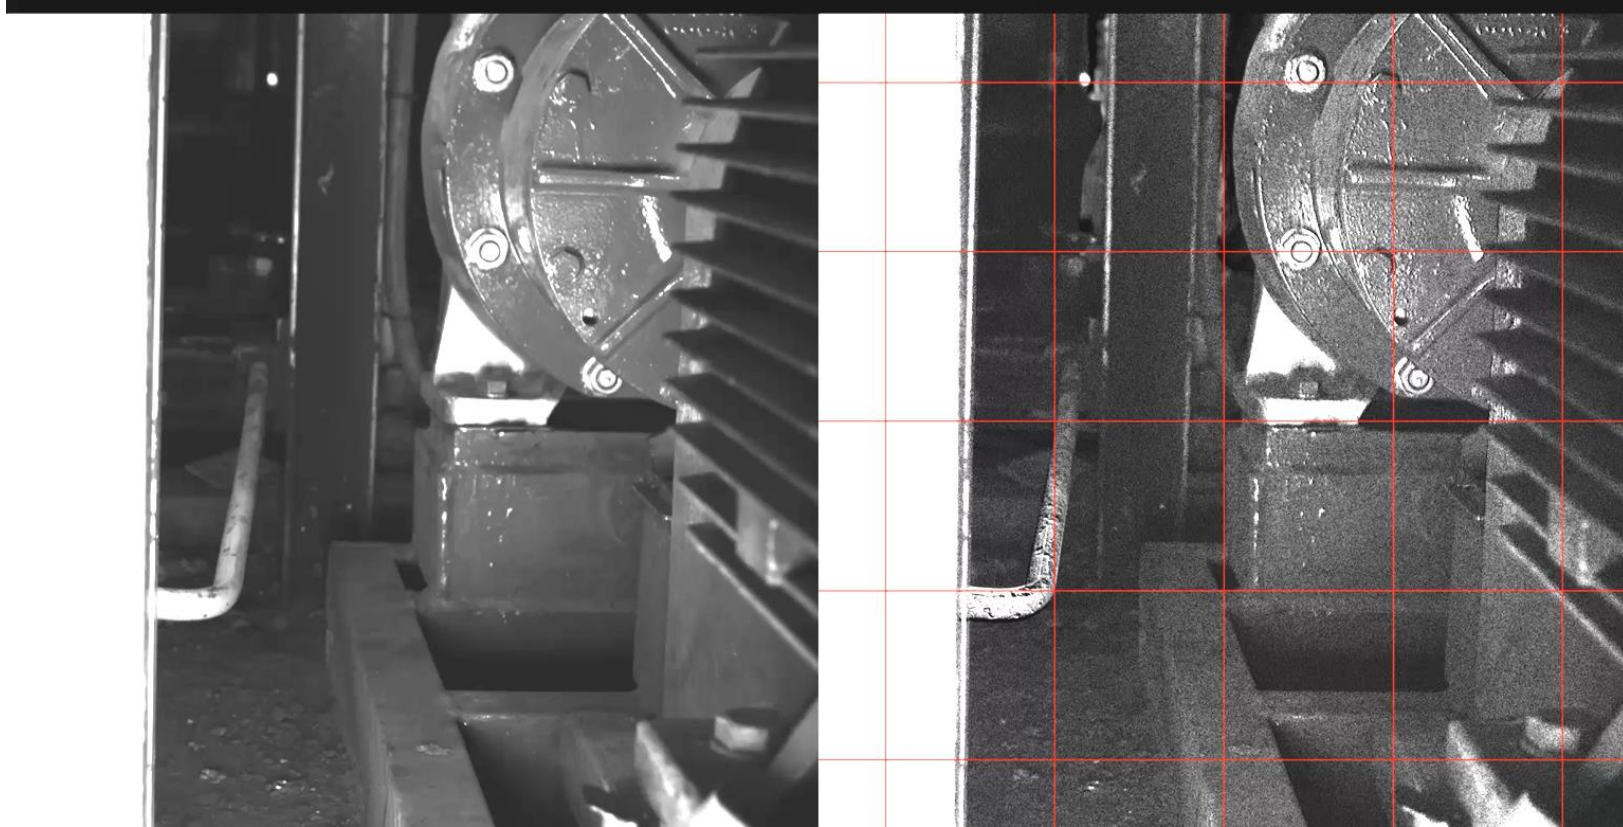
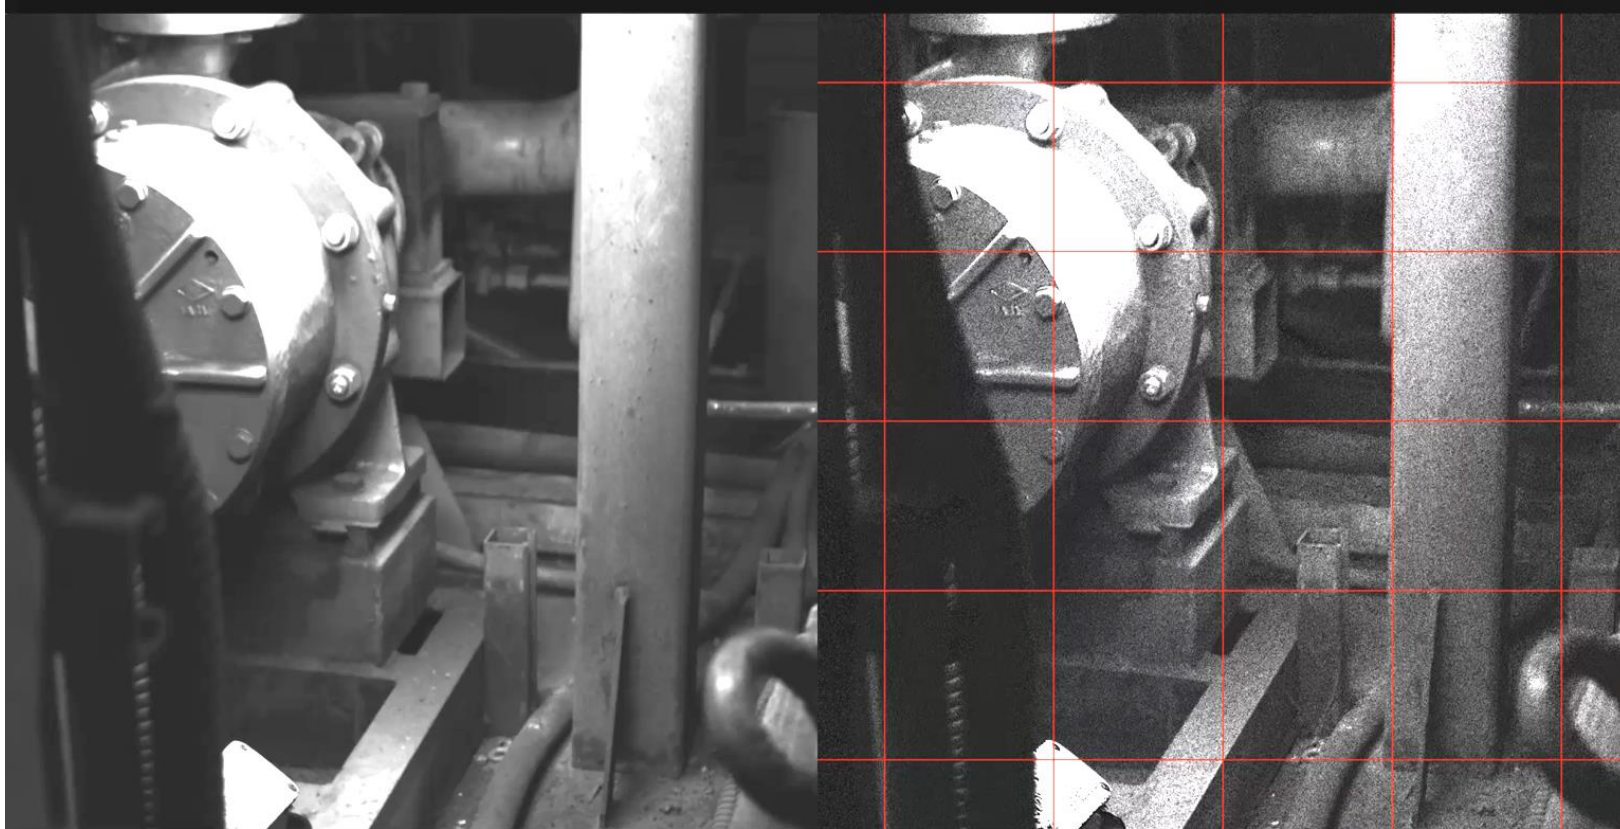
- Motion Amplification revealed issues in the structural integrity of pump base frame
- Majority of Repair Complete– Client confident the problem is now understood
- Prior to Motion Amplification additional repairs were planned that would not have addressed the problem
- MA allows for a quick Root Cause look – quickly isolating issues

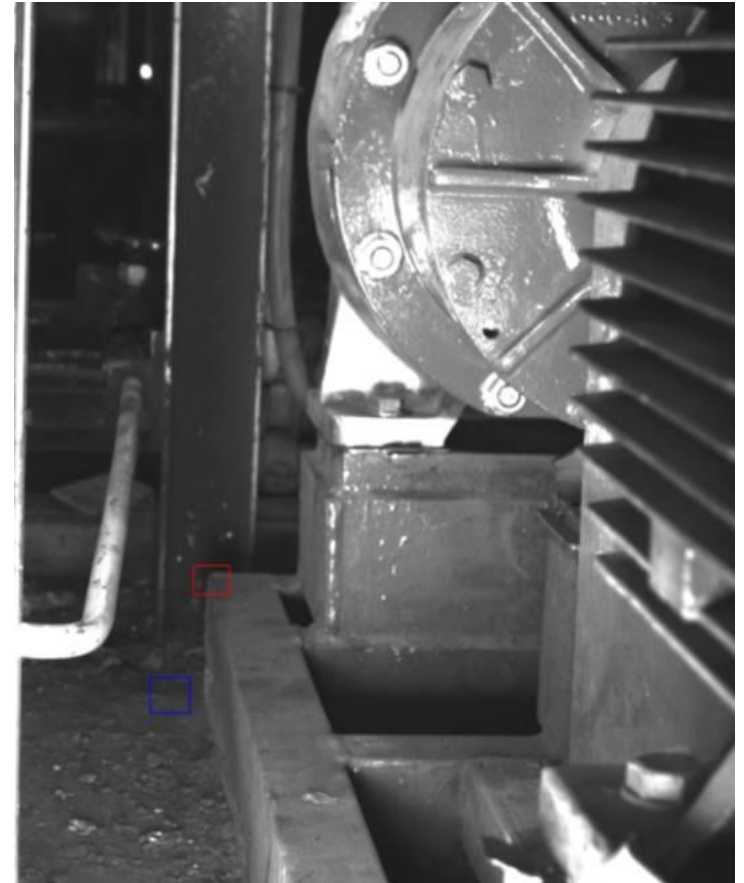
- Main indicator was that there was relative motion (soft foot) between the steel motor/pump frame and the common skid steel base plate
- “There was simply insufficient weld to secure the motor/pump frame properly to the skid base plate”
- ~2 mils Pk-Pk (Red Box on motor/pump frame) vs ~0.4 mils Pk-Pk (Blue Box on skid base plate)

- Root Cause Issue Identified
  - Fillet Welds applied to the interior base support
  - Vibration reduced from 0.55 in/s to 0.15 in/s
  - This is before realignment- expected to improve more.
- 
- *"This has proved to be a great assistance to rectifying a long-term plant issue. After only a short set up time it confirmed our vibration and phase measurement's without physically touching the plant."*

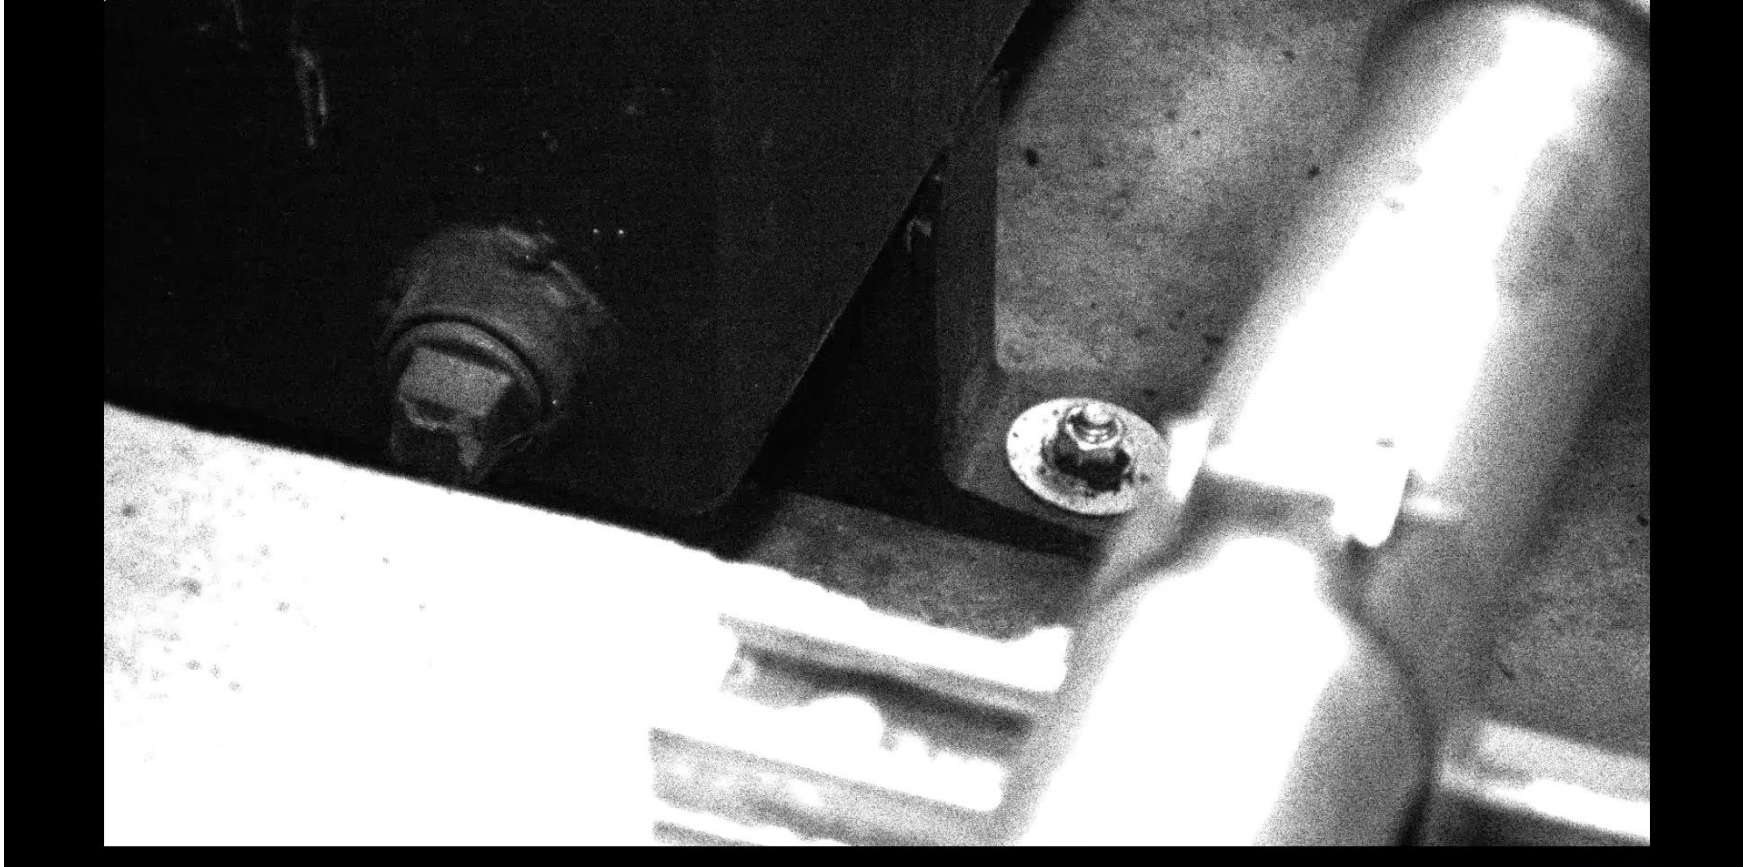
# Hone in on problem

- Operator knew of problem
- Could not determine root cause
- Motion Amplification process < 30 minutes.
- Issue identified as bolt drilled at an angle at install
